SOIL NAIL AND JET GROUTED EXCAVATION SUPPORT WALL AT PEIRCE MILL DAM

Eric M. Klein, P. E., Rummel, Klepper & Kahl, LLP, Baltimore, Maryland, USA

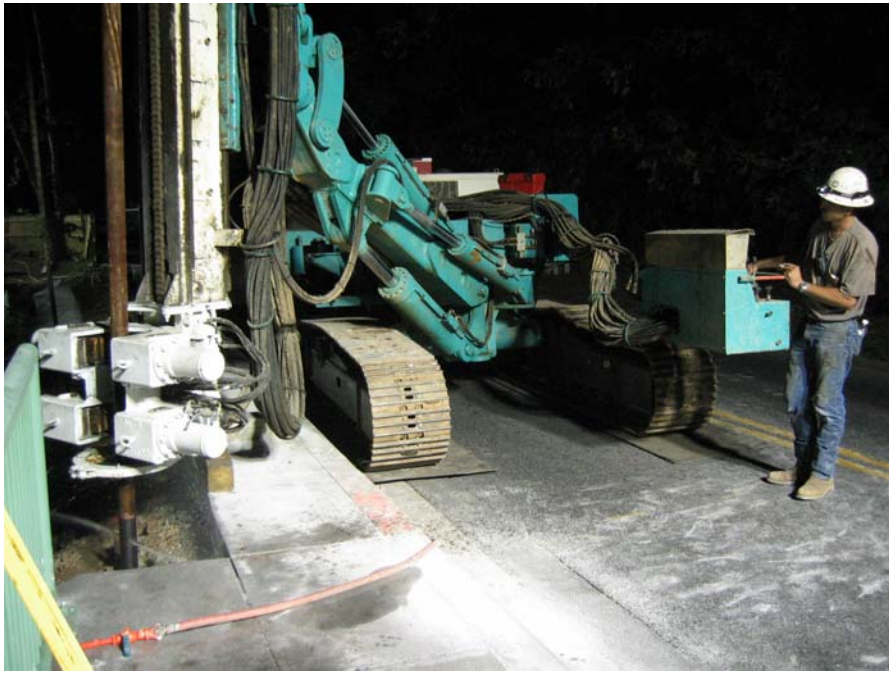
Figure 8 - Jet Grout Installation from Beach Drive Showing Water Jets, Operator and Protective Mats

A total of 59 columns were installed to drilled depths ranging from 11 to 21-ft and the grouted length ranging from 2 to 21-ft. Fractured rock was grouted at the bottom of some of the columns during initial jetting operations. The grout columns were about 3-ft in diameter. A photograph of an excavated test column is shown in Figure 6. Figure 7 is a photograph of the jet grout rig installing a jet grout column.

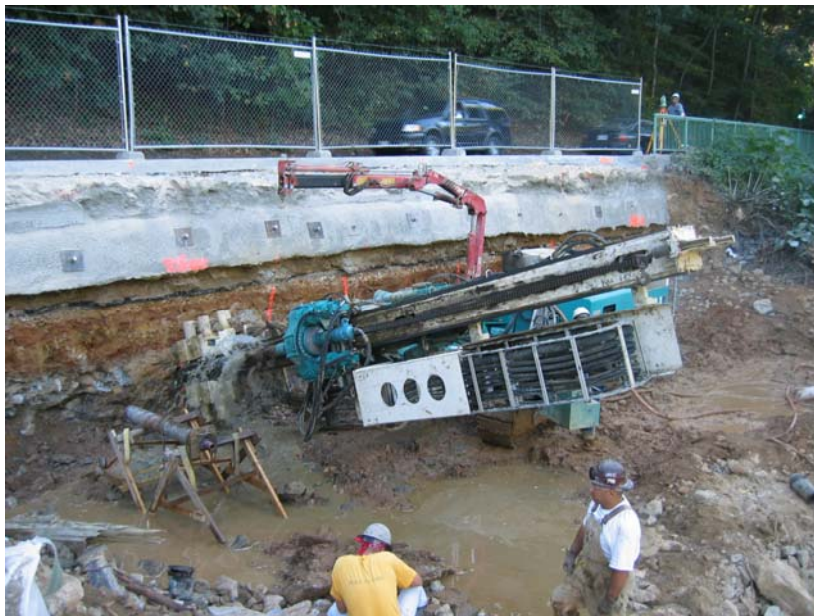
Figure 9 - Soil Nail Installation Showing Old Pavements, Rubble and Soil Fill

The working area was confined to a narrow strip limited by the temporary coffer dam and Beach Drive. This is illustrated in Figures 9 through 11. The equipment could not turn, it had to drive straight in and back out. The grout batch plant and staging area was the parking lot north of the proposed fishway.

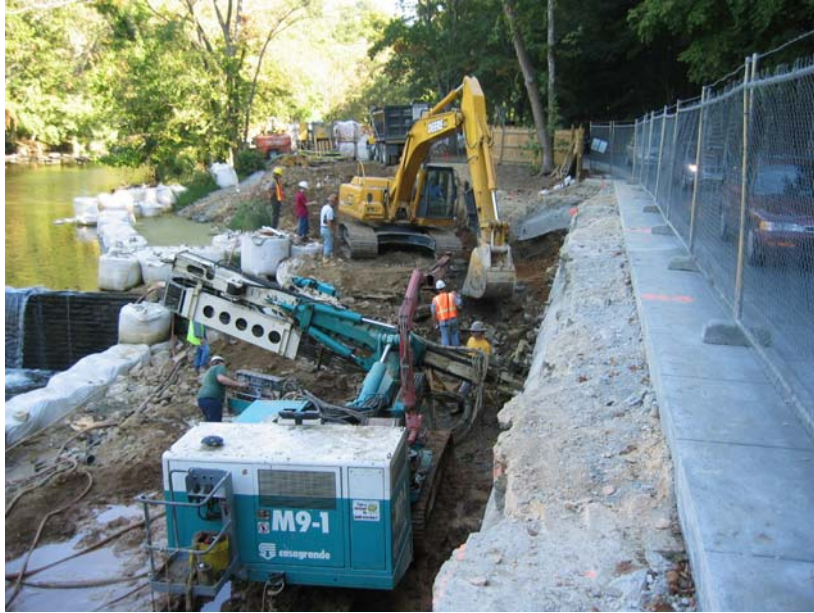
Figure 10 - Soil Nail Installation Showing Proximity of Peirce Mill Dam, Temporary Cofferd Dam and Beach Drive

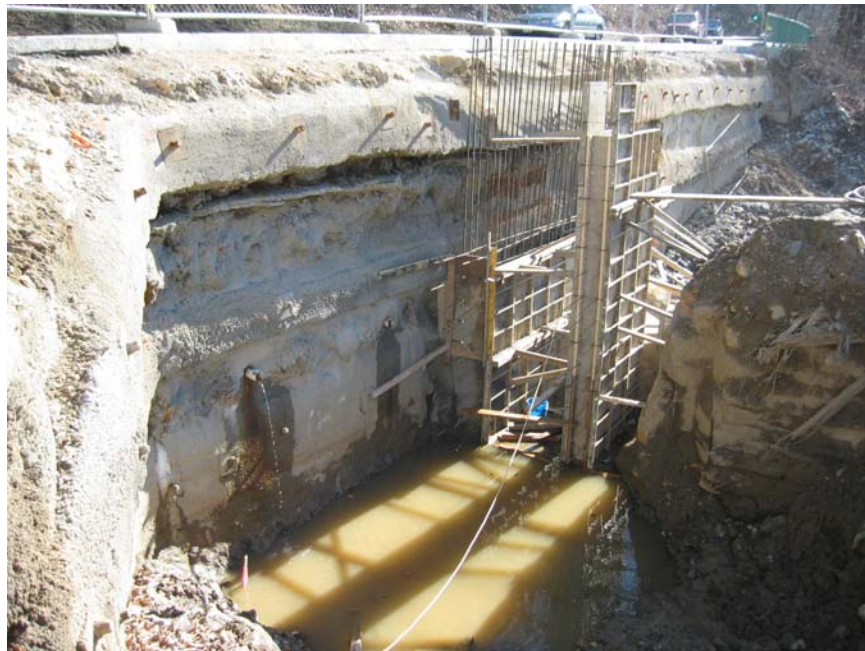
Figure 11 - Finished Soil Nail Wall Showing Weep Holes, the East Abutment of Peirce Mill Dam and the Formwork for the Fishway.

The weep holes shown in Figure 11 flowed continuously illustrating the need that a stable

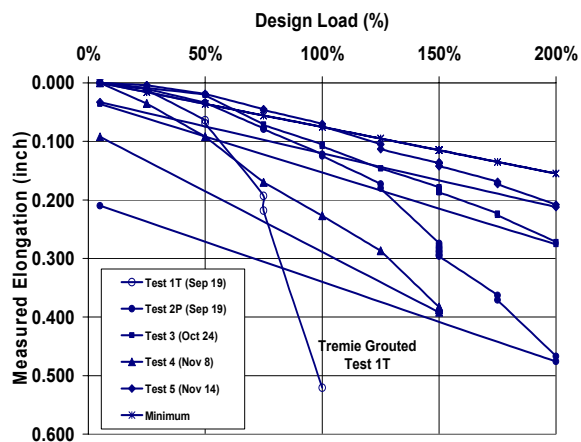
Figure 12 – Verification Load Test Results

test load was 32 kips. The design of the soils was revised and three additional tests were performed October 24, November 8, and November 14, 2005. The new soil nail had a design load of 29 kips, a free length of 96-inches and a bond length of 120 inches. The last production soil nail was installed November 15, 2005. Figure 12 is a plot of all five of the sacrificial verification load tests and the minimum theoretical displacement.

Assuming an effective diameter of 7 inches, the tremied in place soil nail test results indicated an average ultimate resistance of about 1,200 psf (8.3 psi), whereas the pressure grouted soil nail obtained at least 3,200 psf (22psi), thus achieving the minimum required load factor for pullout resistance (0.50). Subsequent verification and proof tests of several additional production anchors confirmed that the minimum safety factors assumed in the design were maintained.

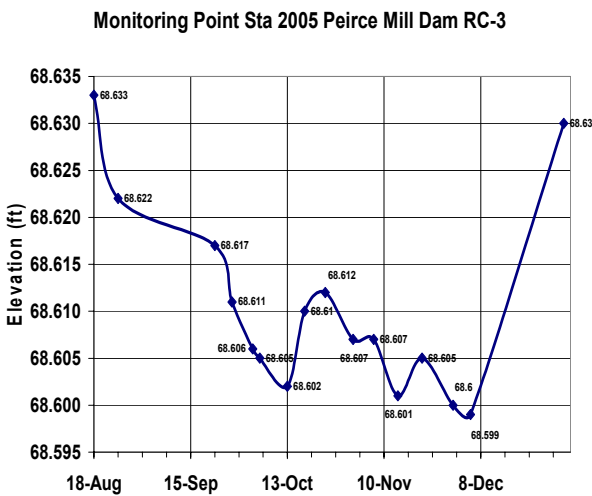
Figure 13 – Monitoring Point STA 2005

An instrumentation program was initiated to monitor wall movements. If excessive wall movements were detected then remedial actions could be taken such as adding more soil nails. The elevations at the top of gutter in Beach Drive and the top of dam were monitored for elevation as the work progressed. The initial readings were taken August 18, 2005, and the final reading was obtained January 1, 2006. The top of gutter settled as much as 0.38-inches by the November 14, 2005: the last week of soil nail installation. A few days later it rebounded 0.048-inches for a total settlement of 0.34-inches during construction of the jet grouting and the soil nailed wall. By December 5, 2005 the gutter settled more for a total settlement of 0.41 inches. The final reading showed a significant rebound that was attributable to frost heave. The rebound events recorded were likely the result of thermal changes and solar heating of the concrete gutter pan as well as extreme rainfall events as described below. There were no noticeable cracks, gaps or mis-alignments noticed in the pavement, gutter pan or sidewalk during construction. Figure 13 plots the results of a monitoring point at the gutter location.

September 2005 was the driest September on record in Washington, D.C.; by October 22, 2005 October was already the wettest October on record. This extreme variation in rainfall could explain some of the unusual settlement and rebounds: they could be due to shrink/swell of the soils as the soils dried out and re-wetted.
